Manhole Inspection Summary

Manhole # S49CC_034MH

Insp Date: **2/19/08 3:13 PM**

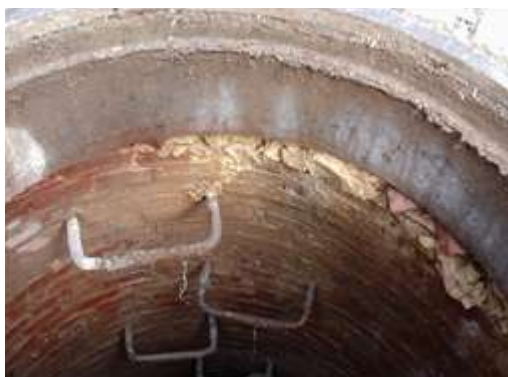
Defect 2

Frame Offset: **0** (in.) Condition: ☐ Sound ☐ Cracked ☒ **Leaks**

frame leaks

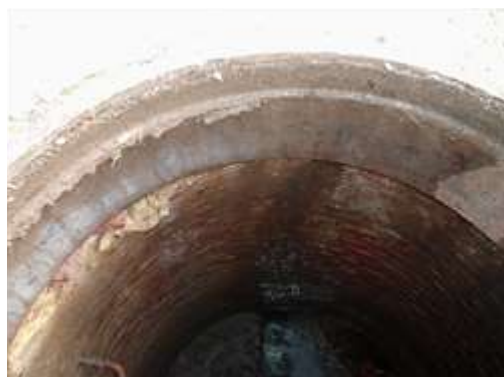
Defect 1

Condition: ☐ Sound ☐ Cracked ☐ Root Intrusion ☒ **Loose Brick** ☒ **Deteriorated**

Infiltration: ☐ None ☒ **Joint** ☐ Cracks ☒ **Mortar** ☐ Roots ☐ Wall

loose bricks

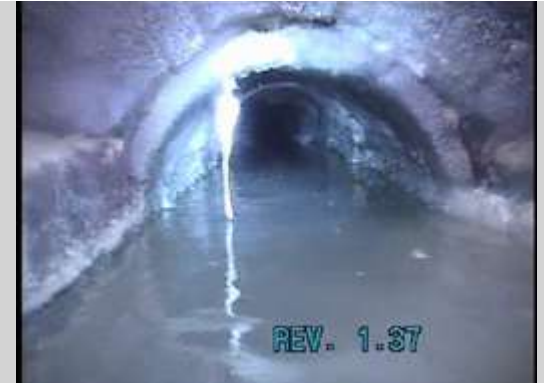
12 O'Clock Outflow

Pipe Height: **12** (in.) Rod and Bar (Angled)
Pipe Material: **Clay** ☐ Pipe Lined
Invert Depth: **8.75** (ft.) Flow Characteristics: **Slow**
Deposits: ☐ None ☐ Mud ☐ Sludge ☒ **Debris** ☐ Grease
Silt Depth: **1** (in.) Deposits Extent: **Light**
Infiltration: **None** Pipe Seal Cond: **Sound**

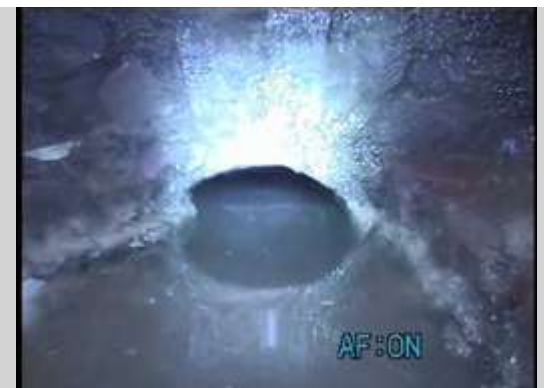
3 O'Clock Inflow

Pipe Height: **8.4** (in.) Rod and Bar (Angled)
Pipe Material: **Clay** ☐ Pipe Lined
Invert Depth: **8.75** (ft.) Flow Characteristics: **Slow**
Deposits: ☐ None ☐ Mud ☐ Sludge ☒ **Debris** ☐ Grease
Silt Depth: **1** (in.) Deposits Extent: **Light**
Infiltration: **None** Pipe Seal Cond: **Sound**

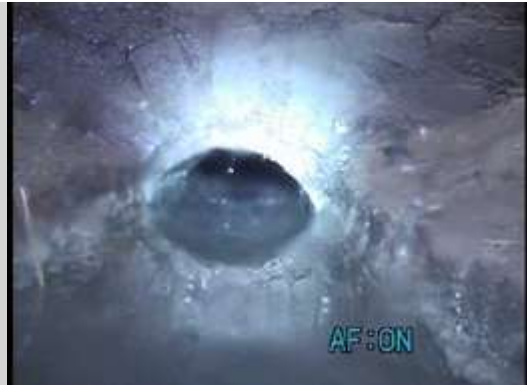
6 O'Clock Inflow

Deposits: ☐ None ☐ Mud ☐ Sludge ☒ **Debris** ☐ Grease

Silt Depth: **1** (in.) Deposits Extent: **Light**
